Rock Slope Assessment at Jalan Bukit Permai, Cheras

Muhammad Syaifuddin Norazman¹, Rini Asnida Abdullah¹

¹Faculty of Civil Engineering, Universiti Teknologi Malaysia, Malaysia ^{a*}asnida@utm.my

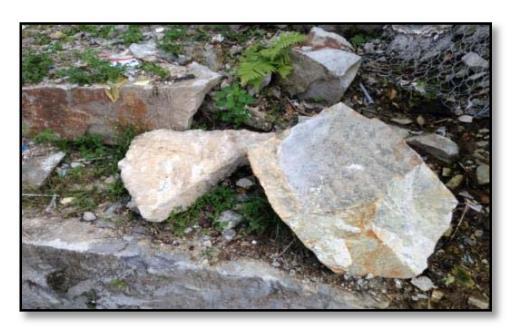
Figure 2: A boulder of rock fall

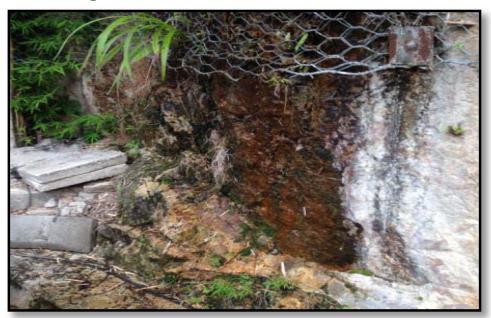
Figure 3: Presence of water flow and trees

Other data such as the weathering grade, the infilling material and water flow on the rock slope is done by observation only. From the slope face it can be seen that a few loose rock due to the weathering and it broke into a smaller pieces of rock. The presence of water flow and trees can also be measured by the observation.

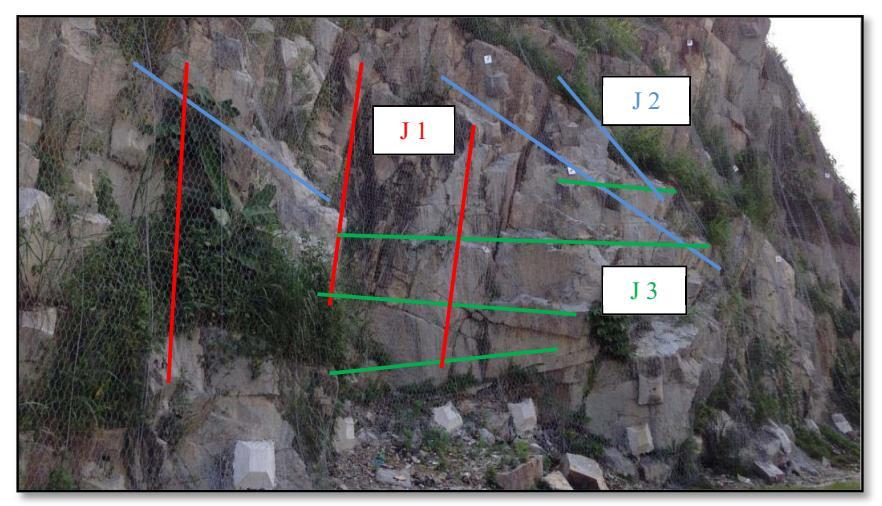
Figure 4: Joint System in Slope 1

Dips 6.0 SoftwareDIPS software is capable of calculating the probability mode of failure based on the unfavourable orientation of discontinuities. Table 5 summarised the probability of failure for Slope 1. It was found that the potential of instability at Slope 1 are due to planar (33%), wedge (100%) and rock fall (33%). Even though the highest instability is from the wedge type of failure, since the block is small in size, it may fail as the rock fall. In addition, there is also evidence of rockfall during the field visit. Therefore, the next analysis will be performed in the Rocfall software as to simulate the rock fall event and determine the end point location.

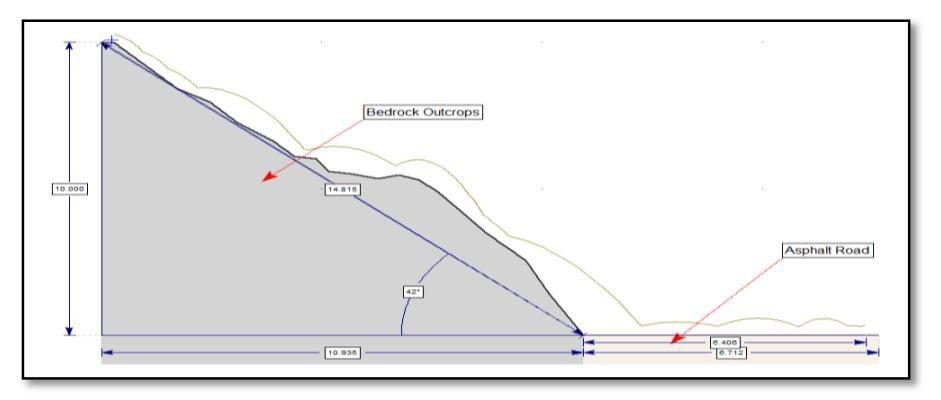
Rocfall 5.0 Software In Rocfall version 5.0, the rockfall is monitors in terms of the rock fall path, endpoint location and maximum kinetic energy. Figure 5 shows the rockfall path and it was found that the endpoint is located at 6.5m from the slope toe. With this end point distance and available buffer zone, the rockfall may hit the passing vehicle. With the maximum kinetic energy of 17 kJ, the passing by vehicle can be damaged from this rockfall event (Figure 6). This kinetic energy is also important for the design of the rock fall barrier.

Figure 5: Model of First Rock Fall Event

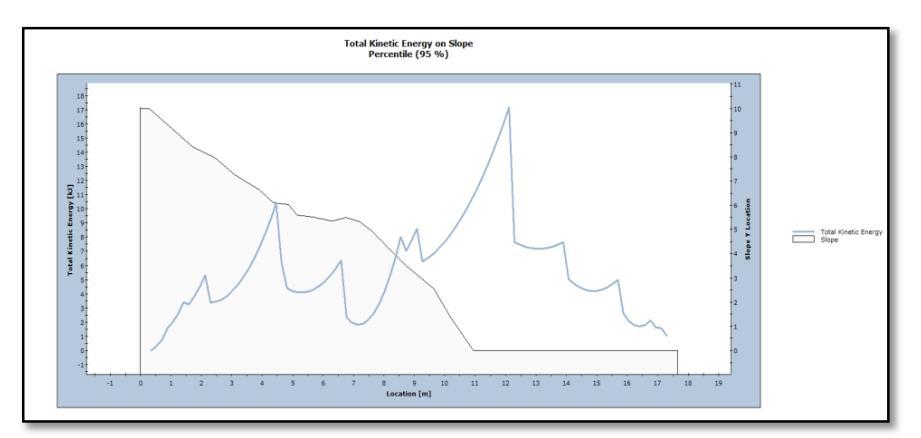
Figure 6: Total Kinetic Energy on First Slope Percentile (95%)

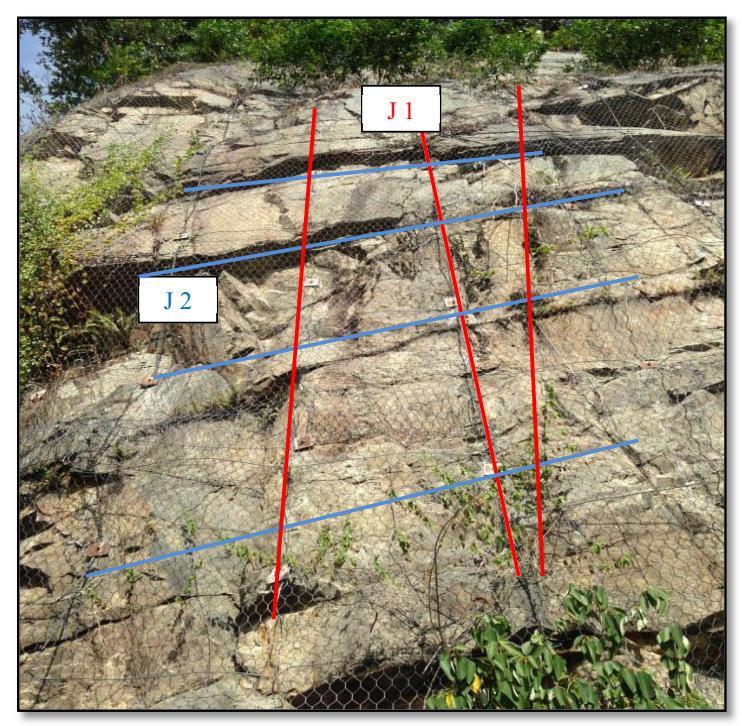
Figure 7: Joint System in Slope 2

Dips 6.0 Software Table 8 summarised the probability of failure for Slope 2. It was found that the potential of instability at Slope 1 are due to planar (50%), wedge (0%) and rock fall (50%). Eventhough the percent of instability is same from the planar and toppling type of failure; it may fail as the rock fall for the toppling condition. Therefore, the next analysis will be performed in the Rocfall software as to simulate the rock fall event and determine the end point location.

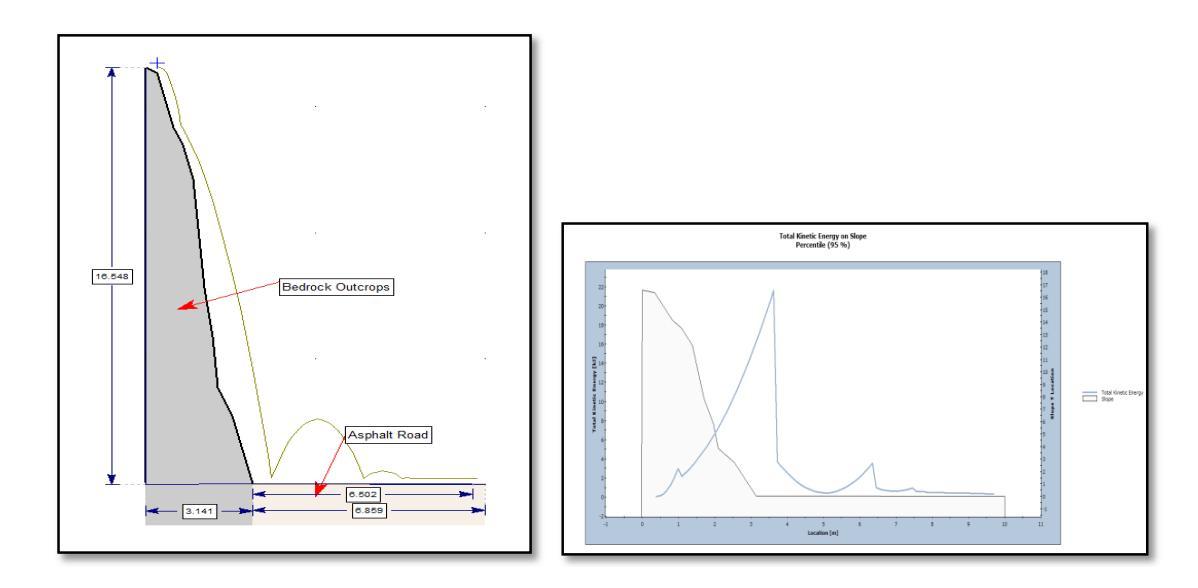
Rocfall 5.0 Software In Rocfall version 5.0, the rockfall is monitores in terms of the rock fall path, endpoint location and maximum kinetic energy. Figure 8 shows the rockfall path and it was found that the endpoint is located at 6.5 m from the slope toe. With this end point distance and available buffer zone, the rockfall may hit the passing vehicle. With the maximum kinetic energy of 22 kJ, the passing by vehicle can be damaged from this rockfall event (Figure 9). This kinetic energy is also important for the design of the rock fall barrier

Figure 8: Model of Second Rock Fall

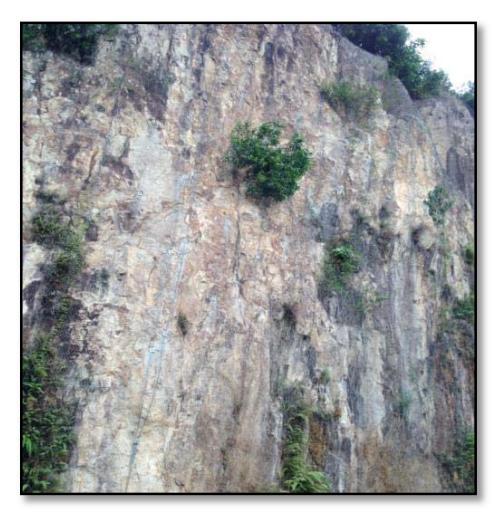
Figure 10: Joint System in Slope 3

Dips 6.0 Software Table 11 summarised the probability of failure for Slope 3. It was found that the potential of instability at Slope 3 are due to planar (0%), wedge (0%) and rock fall (0%). So, the result shows no potential of instability, but based on the visual assessment at that location the remedial work has been installed on site.

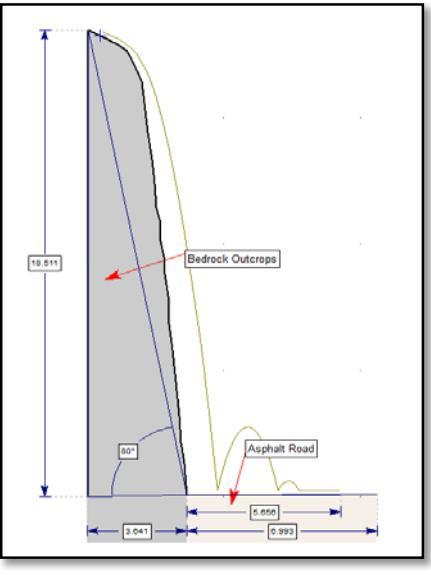
Rocfall 5.0 Software In Rocfall version 5.0, the rockfall is monitores in terms of the rock fall path, endpoint location and maximum kinetic energy. Eventhough, there have no potential of mode of instability at this slope, but below that slope are parking vehicle and residential area, the danger is still have and this simulation will assume the endpoint of that rock fall eventif it happen. Figure 11 shows the rockfall path and it was found that the endpoint is located at 6.6 m from the slope toe. With this end point distance and available buffer zone, the rockfall may hit the passing vehicle. With the maximum kinetic energy of 13 kJ, the passing by vehicle can be damaged from this rockfall event (Figure 12). This kinetic energy is also important for the design of the rock fall barrier

Figure 11: Model of Third Rock Fall Event

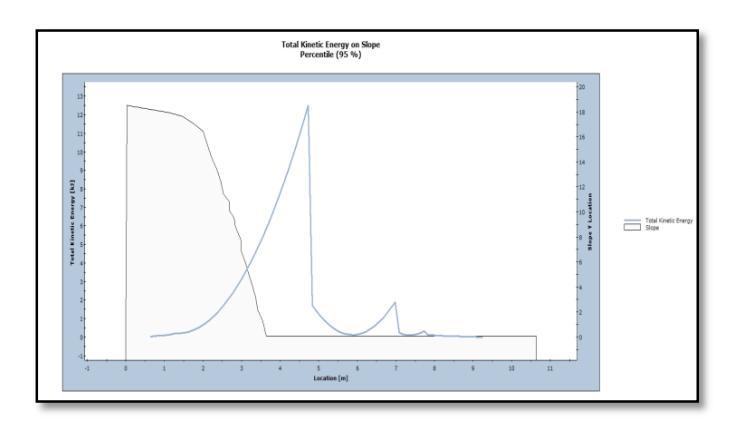
Figure 12: Total Kinetic Energy on Third Slope Percentile (95%)
