Title : **FAILURE OF ROOF STRUCTURE
DUE TO WIND LOAD**

FAILURE OF ROOF STRUCTURE DUE TO WIND LOAD

A project report submitted in partial fulfilment of the
requirements for the award of the degree of
Master of Civil engineering (Civil – Structure)

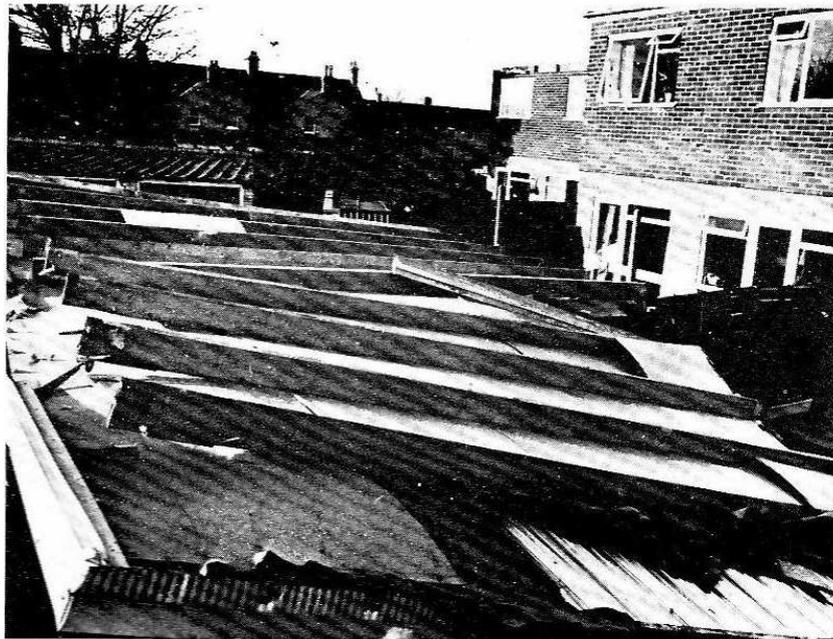
Figure 1.1: Some of the common example of roof failure

Uplifting of the roof structures or roof sheeting during rainstorm has been causing damages to the buildings. Generally, failure occurred at the two points, either at the roof frame's sheeting or at the frame to roof beam connections. There are 2 types of structure are to be analyzed; the different of these two building will be the buildings dimension and geographical locations.

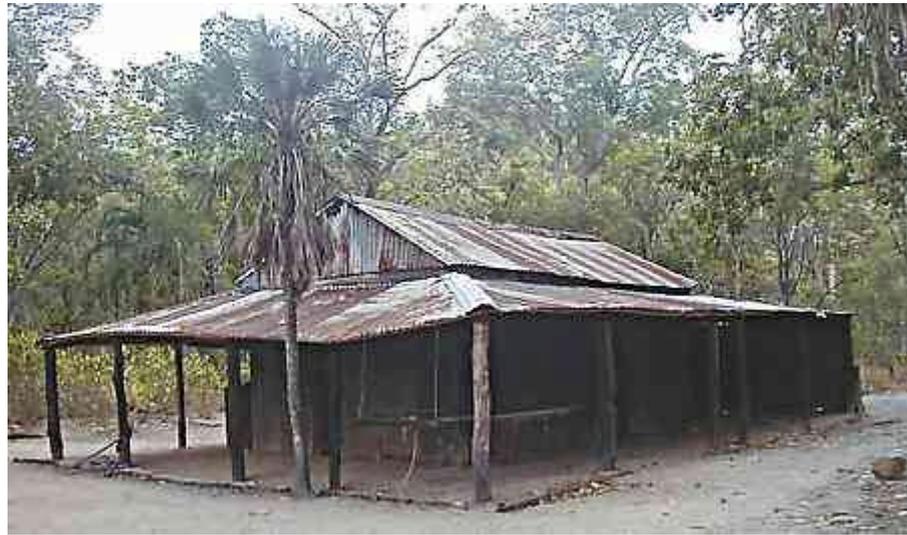
Figure 2.1: An example of outstation homestead of using zinc roof sheeting.
