Experimental Study of IBS Precast Cruciform Column Under Monotonic Pushover Loads

Keywords: Cruciform column; lateral monotonic load; industrialised building system.

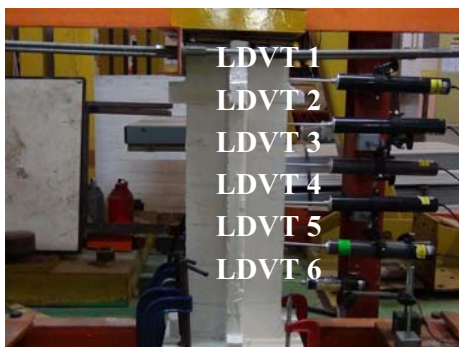
Figure 3: Monotonic Test Set Up

The measurement instrumentation consisted of 6 Linear Displacement Transducer (LDVT) with a schematic illustration as in Figure 3. The measurement that can be gain from the experiment is are the displacement of the structure as load are applied in interval and the amount of load applied. The measurements devices were connected to the data logger which transmitting the output to a personal computer in digital format. The structure was fixed at the base of the testing rig using G clamp and the top of the structure was loaded with weight and the load will be measured through the load cell.

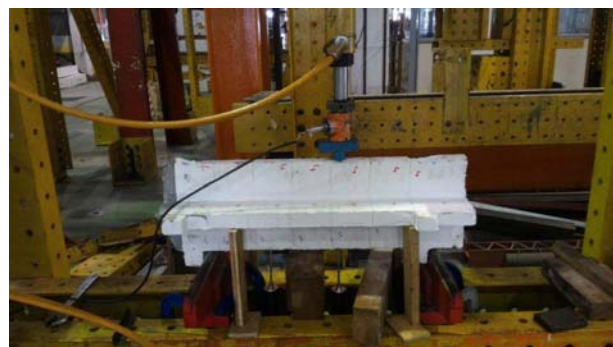
Figure 4: Bending Test Set Up

Bending test is a test for determining the flexural strength of the model by applying force on top of the model. The load was applied at a height of $L/3$ of the column. The parameters that was measured is the displacement or deflection of the model. The measurement are measure by the LDVT and will be recorded to the data logger. In addition, the load applied was measured by the load cell.

Bending test capacity are conducted as the ultimate strength capacity of the column are not fully achieved. The test assembly are differ that monotonic load test. The load are applied to the structure at the height of $L/3$ between the upper and the lower corbel. This is to satisfy the condition between monotonic and bending capacity test where the restraining characteristic would be similar. The first maximum load was at 54 kN before the structure have started to fail and the final load was at 48.7 kN. The test ended when the structure are 10 mm displaced vertically when the structure have been considered failed.

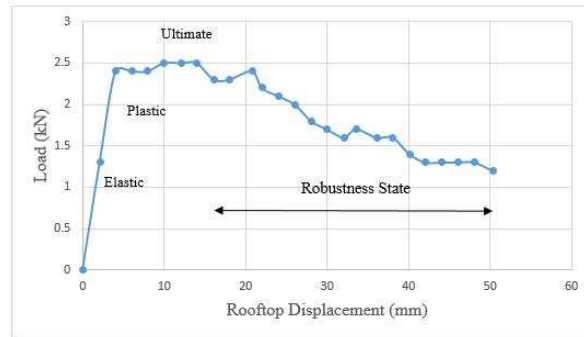
Based on the graph in Figure 5, the applied load on the rooftop of the model are steadily increase until it become constant under 2.5 kN of load at 10 to 14 mm of displacement. Besides, reduction of load occur after reaching 16 mm of displacement which is 2.5 kN to 2.3 kN. This point was the first crack began to appear in the footing near the bottom of the last block corbel. Then, the load gradually reduced as the displacement are increase.

Figure 5: Load (kN) versus Rooftop Displacement (mm) for Column with Footing

Comparison of Monotonic Analysis of Column with Footing between Experimental and Frame Analysis. At load 2.5 kN, the rooftop displacement from frame analysis is 0.231 mm while for graph at Figure 5, the rooftop displacements is 14.04 mm. The differences between these values are due to the contact joint between column and footing are not sufficient to hold the column. This is due to no reinforcement connection between column and footing as the only reinforcement are exist inside the

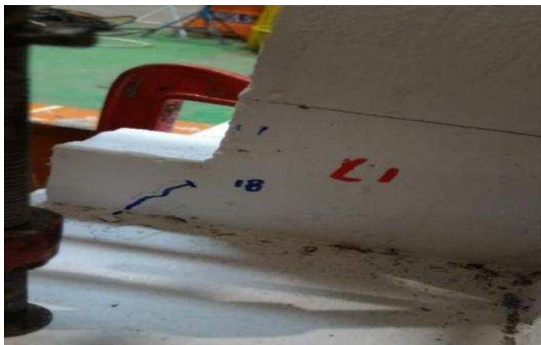
Below figures shows some of the cracking and spalling that occur during the testing. The cracking begin to appear at 16 mm of displacement at load 2.3 kN and become obvious when reach 18 mm of displacement (Figure 6). The crack extended to the lower part of the corbel when reach 28 mm of displacement at 1.8 kN (Figure 7). Cracking appear at the top side of the footing at 30 mm of displacement at 1.7 kN (Figure 8). The column have lifted where the column and footing had separated. Cracking at footing also occur at 42 mm of displacement at 1.3 kN (Figure 9). Cracking and Spalling occur at 44 mm of displacement at 1.4 kN (Figure 10). The footing crush after reaching 46 mm of displacement as shown in Figure 11 and the testing was stopped at 50 mm of displacement.

Figure 6: Cracking at Footing and L1

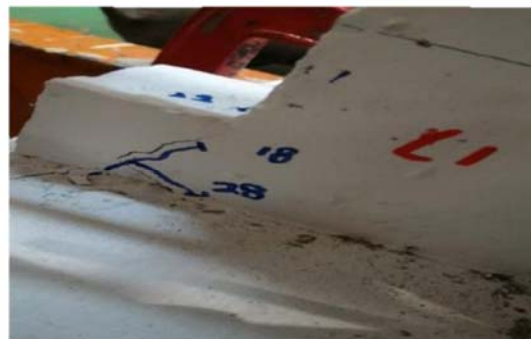
Figure 7: Crack Extended to Lower Part of Corbel

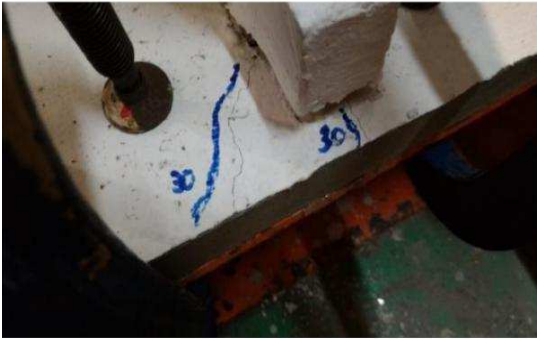
Figure 8: Crack at Top Side of Footing

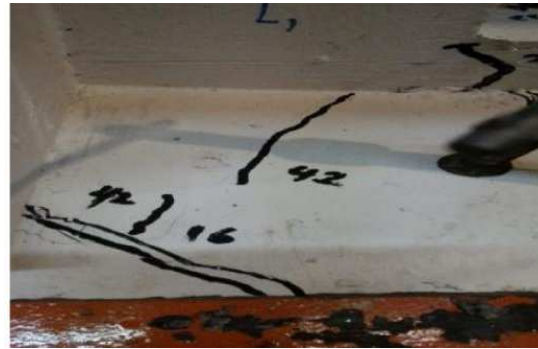
Figure 9: Crack at 42 mm of Displacement

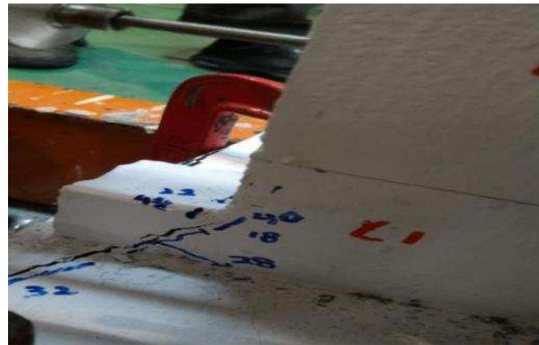
Figure 10: Crack at 44 mm of Displacement and Spalling

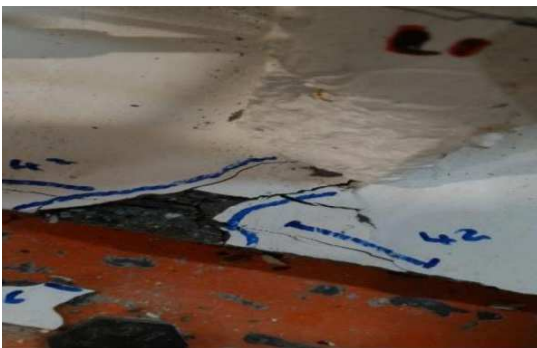
Figure 11: Spalling and Crushing at Footing

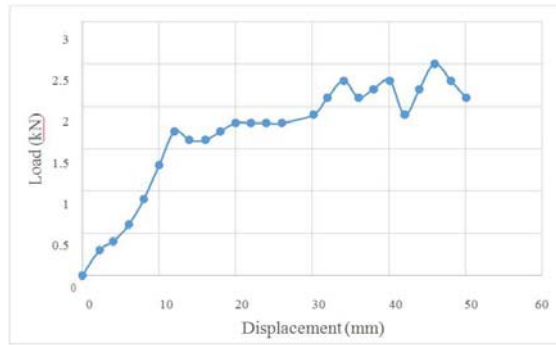
This test is to carry out to determine the behaviour of column without footing and as well to gain the ultimate flexural strength of column that was not acquired during the first test. Similar to the first test, the structure are loaded form zero with increasing of 2 mm displacement interval. The load drop from 1.7 kN to 1.6 kN when it reach 12 mm of displacement. Then it became constant at 13 mm and 16 mm of displacement of displacement and raise backward. This is due to the column are skidding on the supports as the load are applied to it.

Figure 13: Load (kN) versus Rooftop Displacement (mm) for Column without Footing

Comparison of Monotonic Analysis of Column without Footing between Experimental and Frame Analysis. At load 2.5 kN, the rooftop displacement from the graph in Figure 27 is 0.617 mm while for Figure 13, the rooftop displacement is 46 mm. The cause of this difference are due to insufficient strength of the G clamp as the load applied. Every increment of load causes the column to skid away from G clamp. In addition, as the load are applied, some of the G clamp have broken during the testing. Hence, the failure obtain are due to insufficient restraining of the model that result in high rooftop displacement.

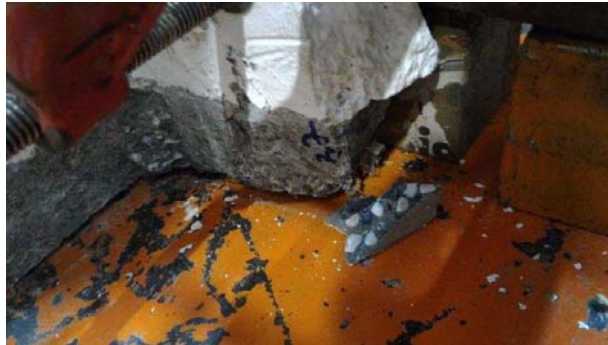
The column show do not show any sign of failure even though the displacement have reach above 20 mm. The first defect that emerge is at 32 mm of displacement where the corbel undergo crushing at L1. The testing are stopped when reach 50 mm of displacement and there are no sign of other defect on the column structure. During this test, at 40 mm of displacement, one of the G clamp broke because not strong enough to withstand the force as the load applied. Below Figure 14 shows the only defect from the testing.

Figure 14: Crushing of Corbel at 32 mm of Displacement

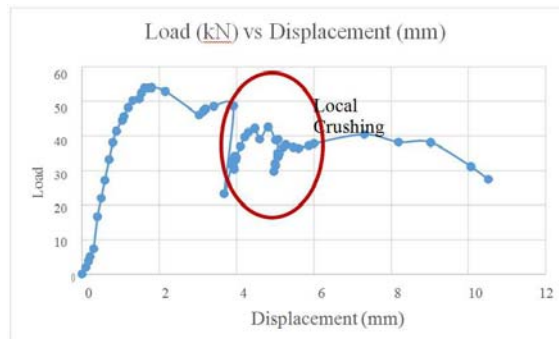
Based on the graph in Figure 15, the load are steadily increase as the displacement are increase. When the displacement reach 1.48 mm of displacement, the first cracking occur at the back of column at LV5. When the displacement reach 2.2 mm the load 52.9 kN dropped to 46.1 kN when it reach 3.03 mm. The drop of load is due to the column have undergo crushing at the area where load is applied. The load tend to increase back as the displacement increase. Then, a massive drop have occur from 3.9 mm to 3.7 mm of displacement. The loading also have a massive drop which from 48.7 kN to 23 kN. An explosive crushing occur at the top surface and front column. The test are stopped when the displacement have reach 10.4 mm of displacement. The column had totally failed and crushed. Therefore, the ultimate strength of the column is at 54 kN as it is the most highest load that the column can withstand. Figures 16 to Figure 24 shows the damages that occur during the test are conducted.

Figure 15: Load (kN) versus Displacement (mm) for Bending Test Capacity

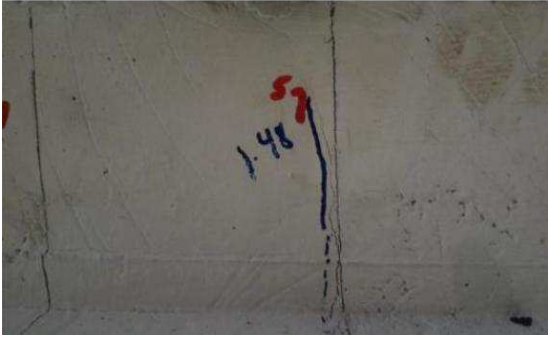
Figure 16: First Crack at 1.48 of Displacement

The first crack begin to appear at 1.48 of displacement at load 50.7 kN (Figure 16). As the displacement reach 2.7 mm, cracking and crushing occur at the top front of L5 of the column (Figure 17). The top surface also occur cracking and nearly crush. Cracking and spalling also occur at the back bottom at L4 (Figure 18). Moreover, the crack also extended from top to bottom at 2.7 mm of displacement. When the displacement reach to 3.7 mm, top surface undergo crushing at 23.3 kN (Figure 19). As the displacement reach 3.9 mm at load 33 kN, crack extended and spalling occur at L4 (Figure 20). The displacement increase and cracking occur at bottom of L6 at 3.9 mm of displacement (Figure 21).

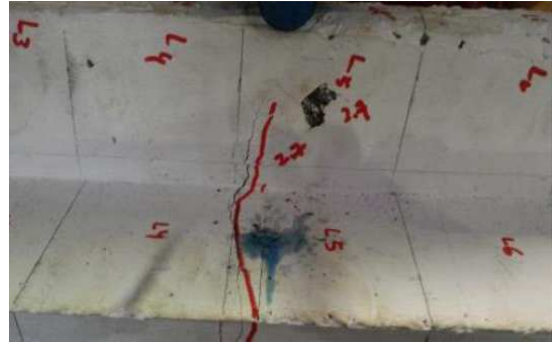
Figure 17: Top Front Cracking and Crushing at L5

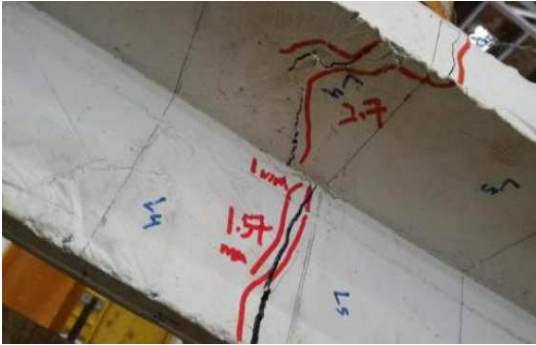
Figure 18: Back Bottom Cracking and Spalling at L4

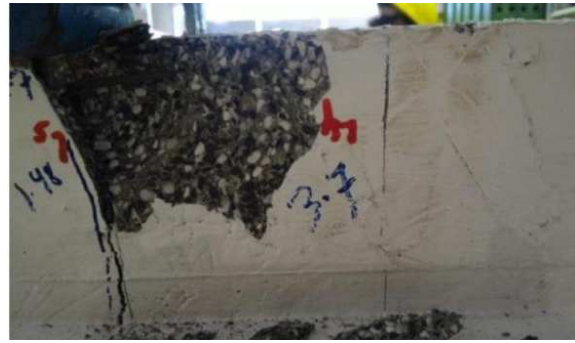
Figure 19: Top Surface Crushing

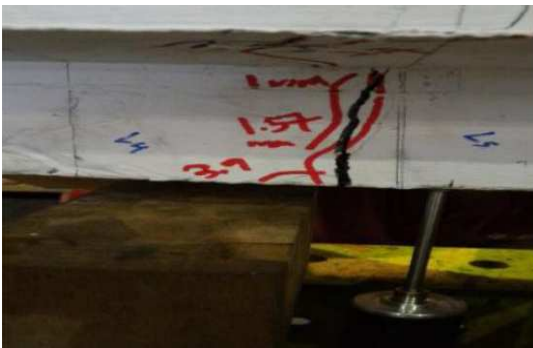
Figure 20: Crack Extended and Spalling

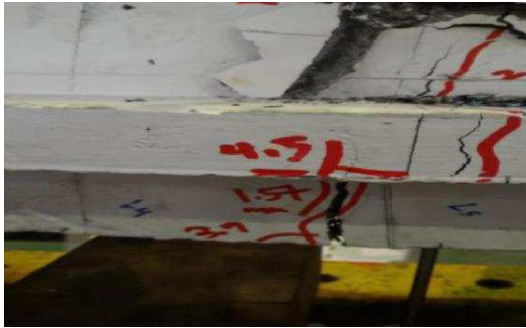
Figure 22: Minor Cracking

As the displacement increase to 4.5 mm, minor surface crack at front exist (Figure 22). After this point, the loading tend to drop from 42 kN until 39 kN. Then, the loading increase back and graduallu increase until 10.4 mm of displacement. The top surface part undergo crushing at 10.2

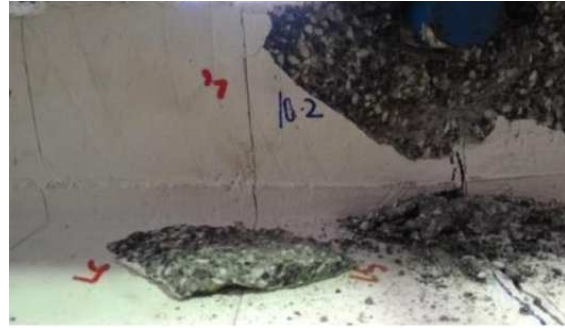
Figure 23: Crushing at 10.2 mm of Displacement

mm of displacement (Figure 23). The column had totally failed when reach 10.4 mm of displacement and the testing are stopped.
